Influence of Ingested Nuclear Cloud Dust and Overpressure Waves on Gas Turbine Engine Behavior (U)

Michael G. Dunn
Calspan Corporation
P.O. Box 400
Buffalo, NY 14225

November 1993

Technical Report

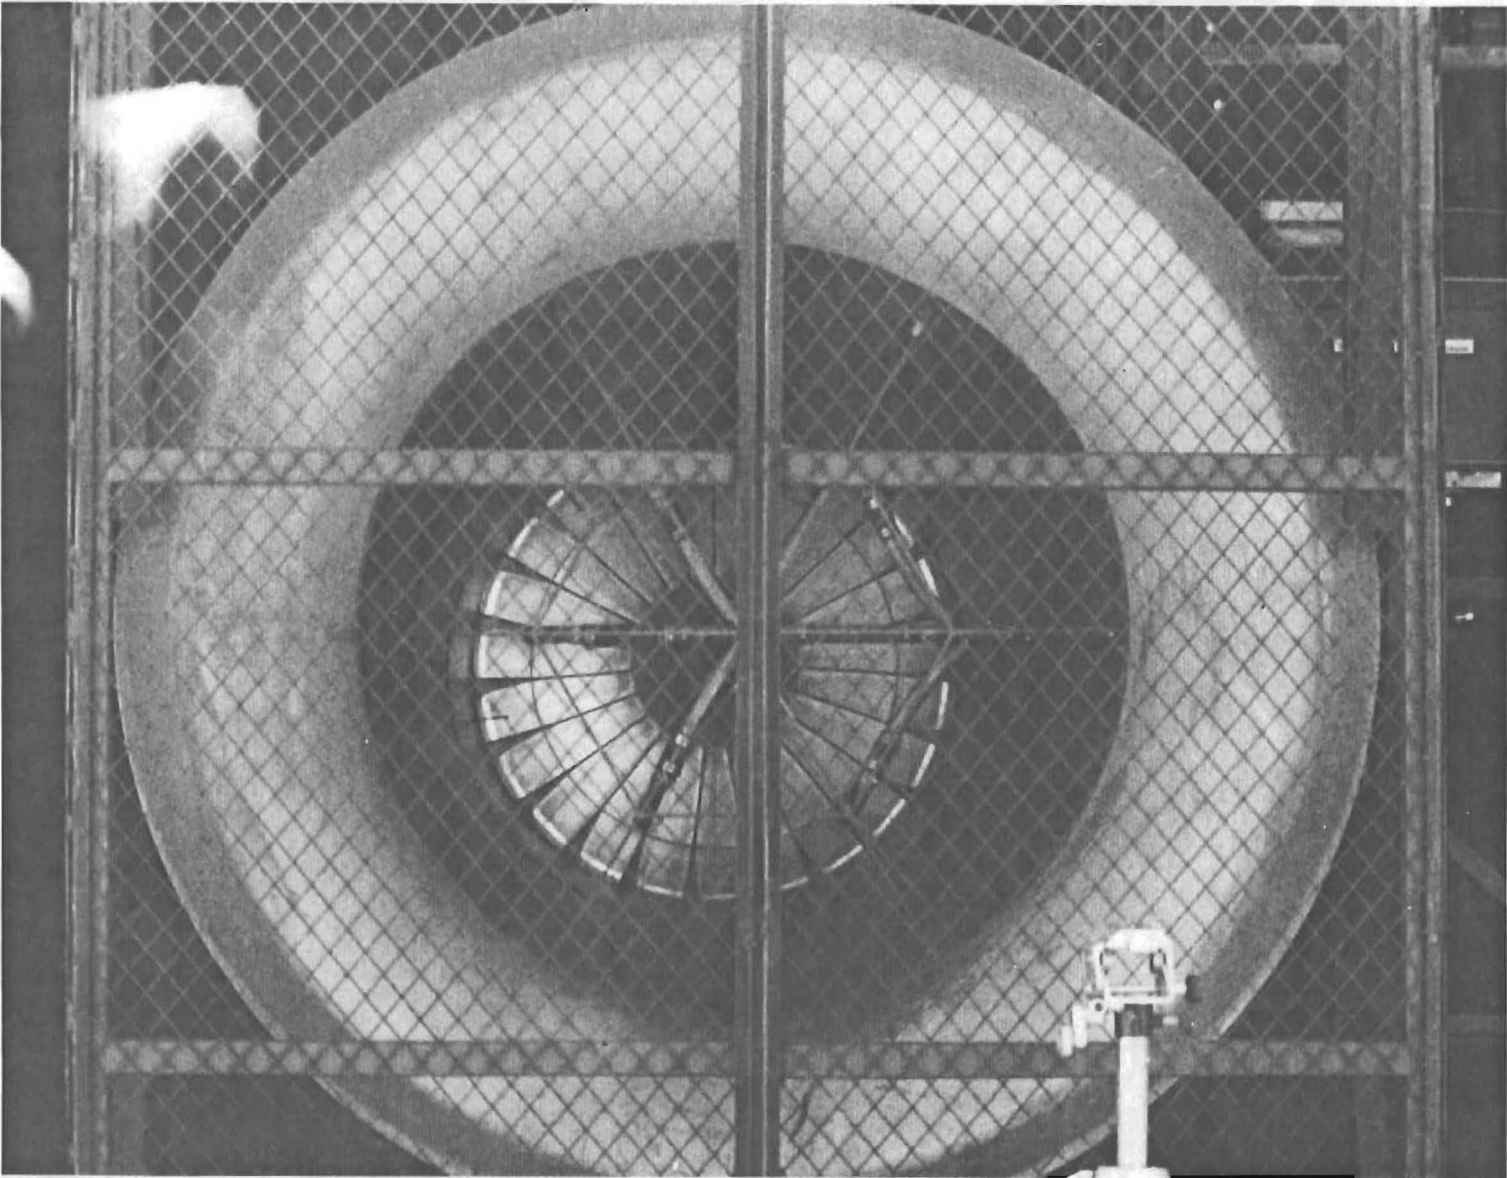
Figure 2.1. (U) Photograph of St. Elmo's glow at fan face of P/W TF-33 turbofan.

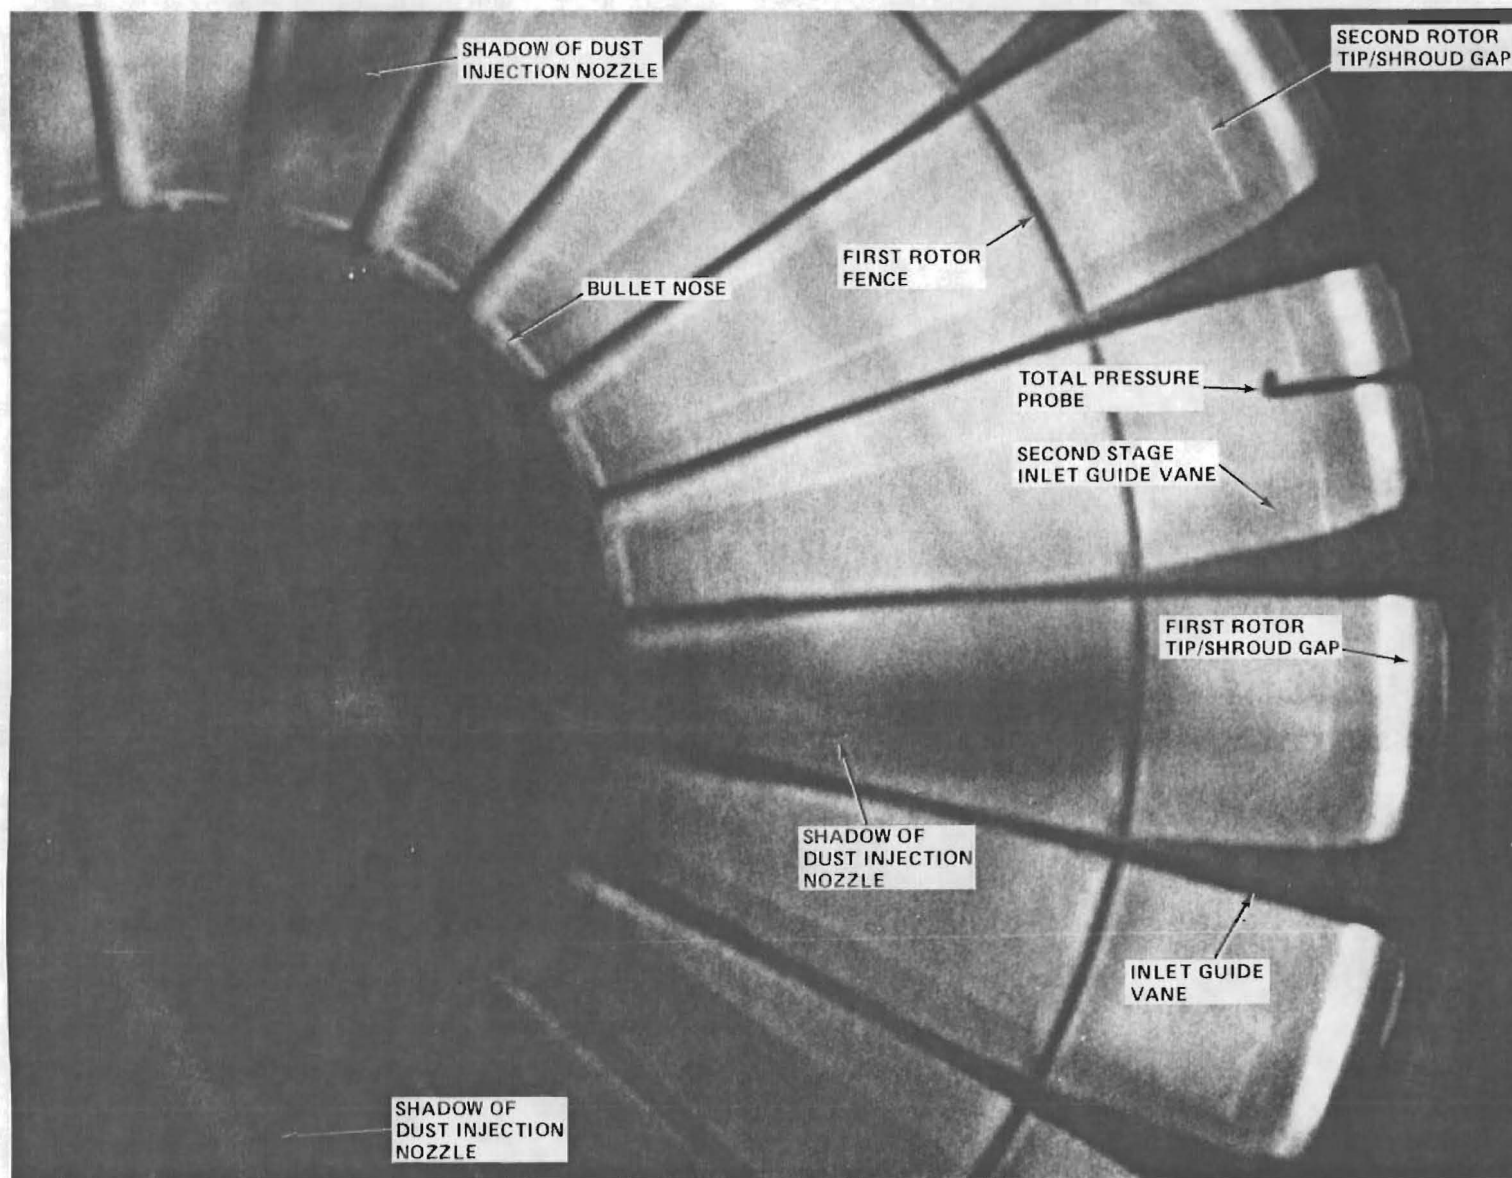
Figure 2.2. (U) Closeup photograph of St. Elmo's glow at fan face of P/W TF-33 turbofan.

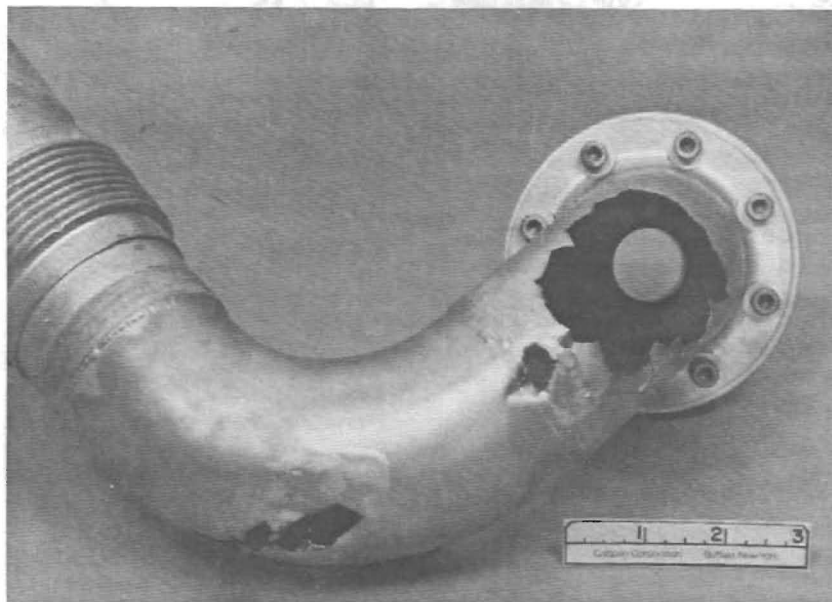
POST-TEST PHOTOGRAPH
P/W TF-33
BLEND #2
EXPOSURE TIME \cong 16 minutes
AMOUNT OF DUST COLLECT \cong 10 g

Figure 2.3. (U) Post-test photograph of ECS plumbing for TF-33 engine after dust exposure.

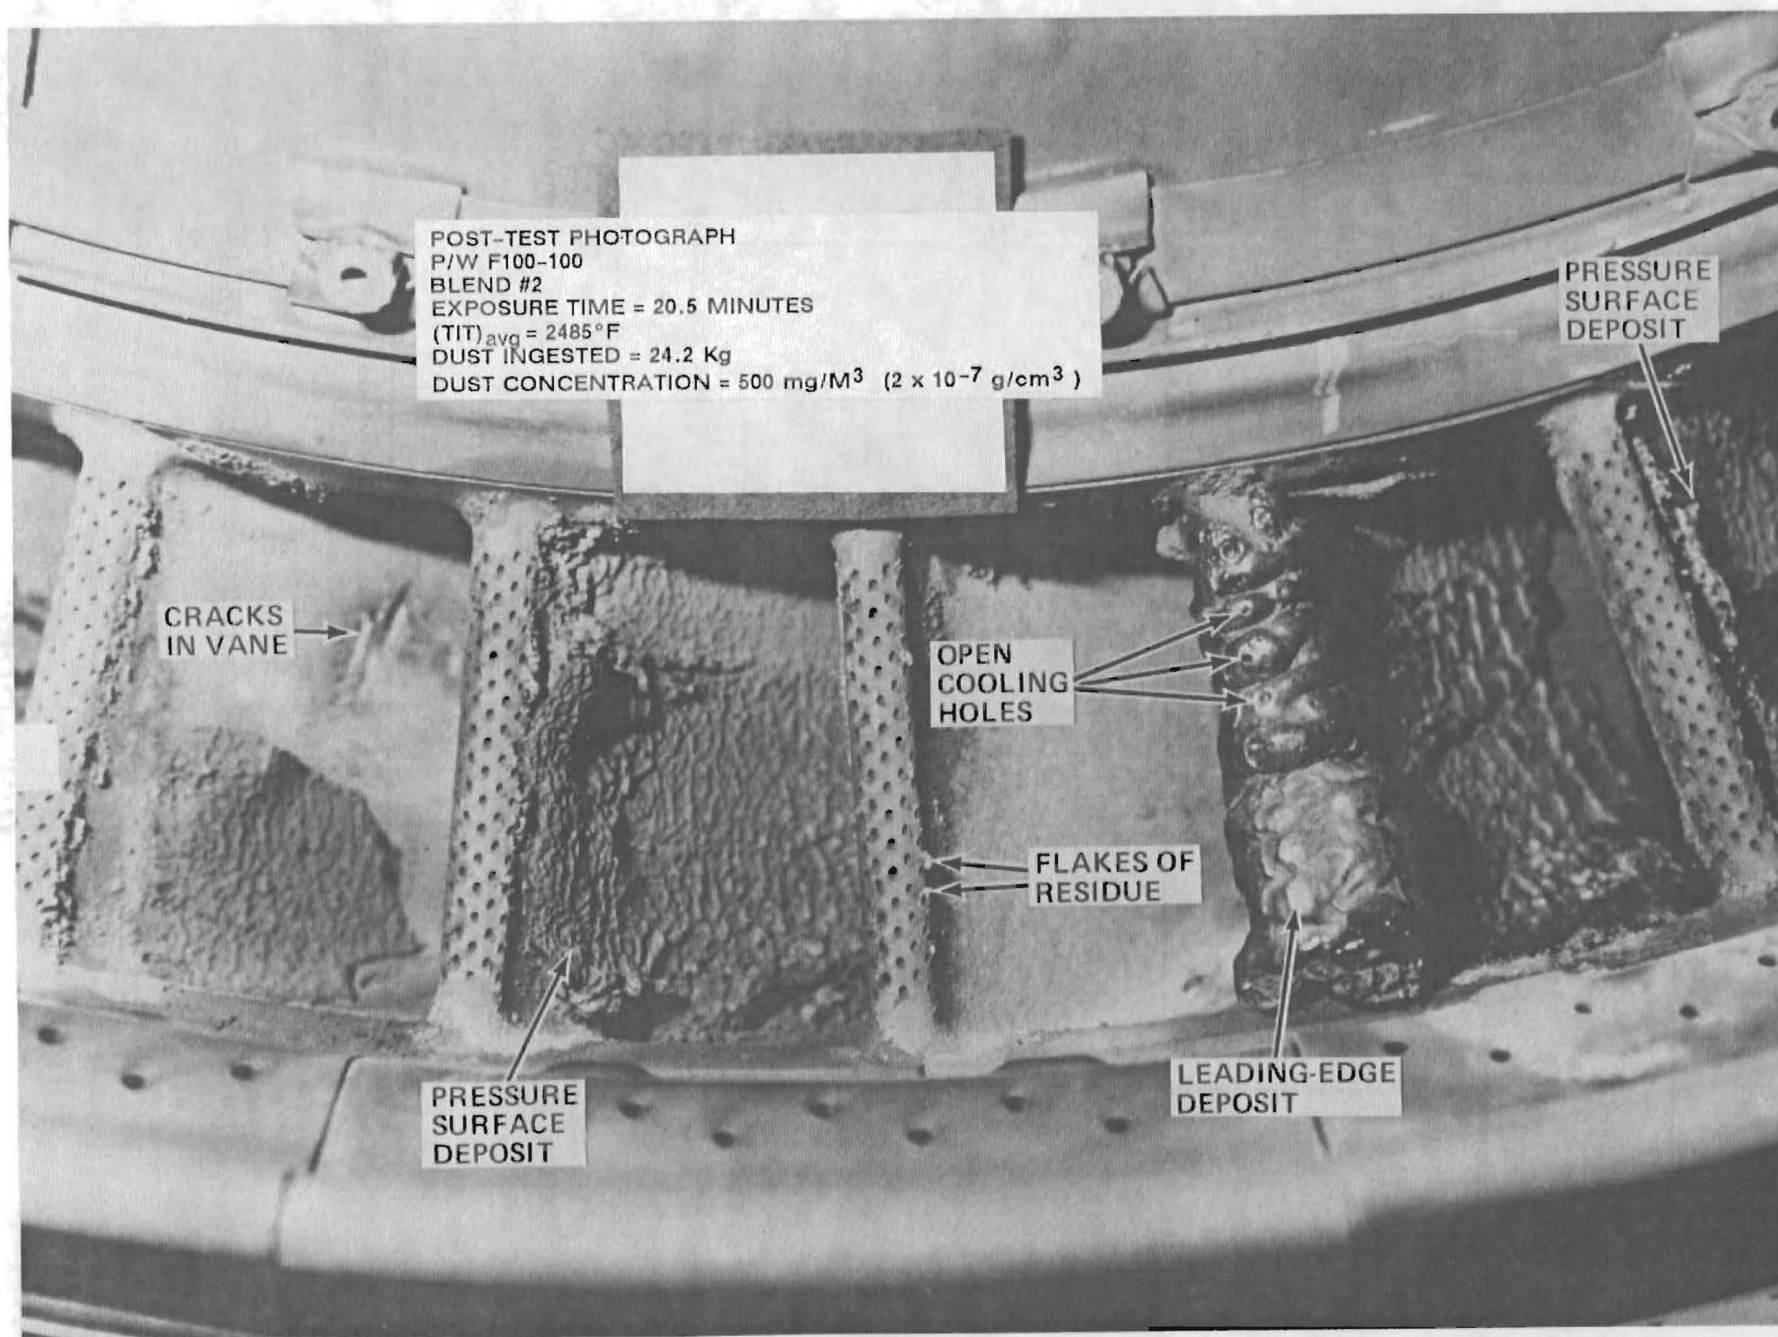
(u) As was noted above, the buildup of material on the first vane causes the very rapid increase in burner static pressure and in compressor discharge static pressure shown in Figures 4.7. At high altitude, this pressure increase can lead to surge and engine flame-out. If the engine surges at high altitude, then flame-out is more likely than at low altitude. The air crew must be aware that a high-altitude engine restart is significantly different from a low-altitude restart. Boeing Commercial Airplane Company has recently changed their procedure instructions to airmen regarding this event and it is anticipated that other companies will soon follow suit. In addition, Boeing has made a videotape for air crews that treats this problem in some detail.

Figure 4.10. (U) Photograph of first vane for F-100-PW-100 high-pressure turbine after dust exposure.

POST-TEST PHOTOGRAPH
P/W F100-100
BLEND #2
EXPOSURE TIME = 20.5 MINUTES
(TIT)_{avg} = 2485°F
DUST INGESTED = 24.2 Kg
DUST CONCENTRATION = 500 mg/M³ (2×10^{-7} g/cm³)

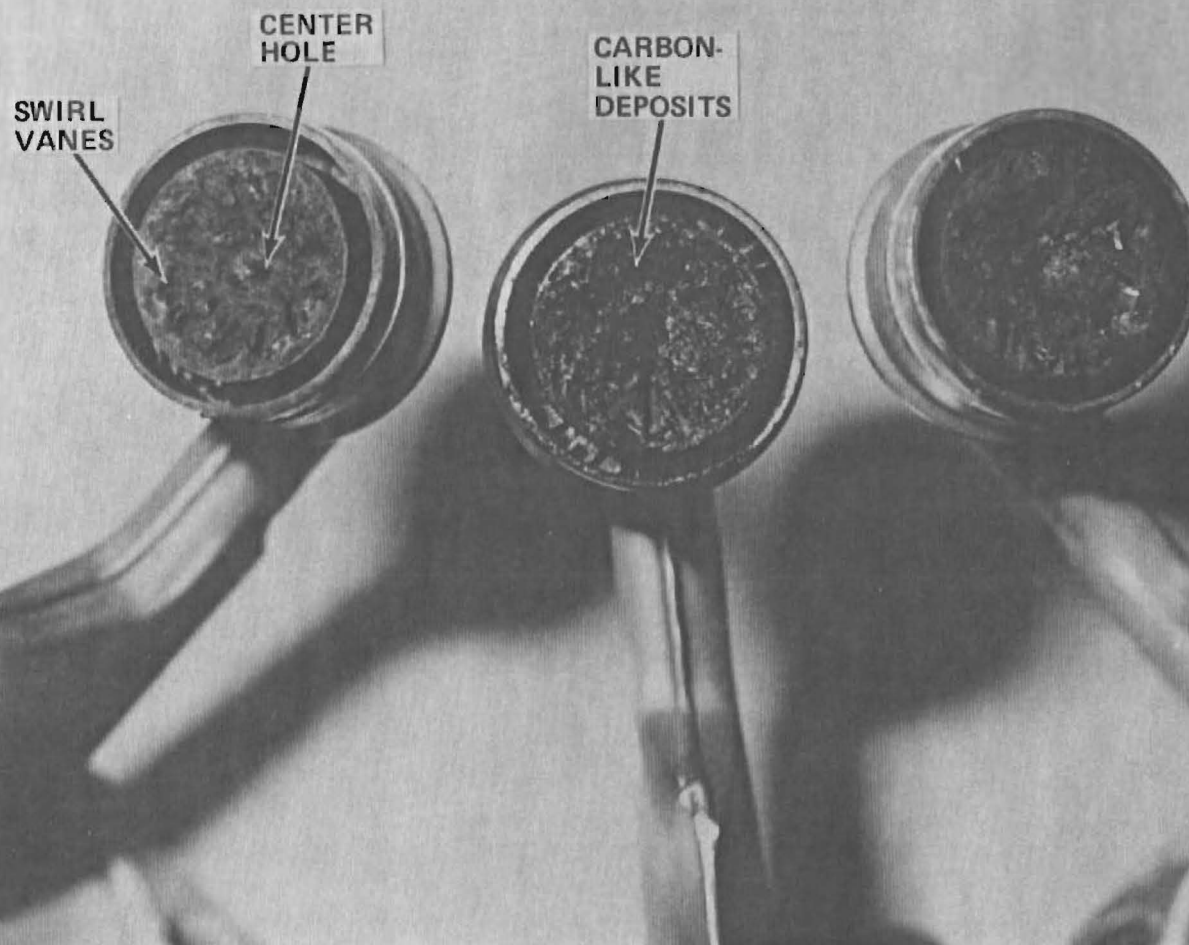
(U) Figure 4.11 is a photograph of three fuel nozzles taken from the same F-100 engine. The material on these nozzles was removed and subsequent analysis indicated that it was carbon. The center hole of the nozzle from which the fuel is sprayed was open and was found to be capable of passing fuel at the design flow rate. However, the air swirl vanes were plugged thus inhibiting atomization of the fuel. The engine from which these fuel nozzles were taken surged violently and had to be shut down because of an excessive tailpipe fire (due to the rapid throttle movement described above). After putting the fire out, which was done without damage to the engine, many unsuccessful attempts were made at restarting.

Figure 4.11. (U) Close-up of photograph of F-100-PW-100 fuel nozzles after dust exposure.

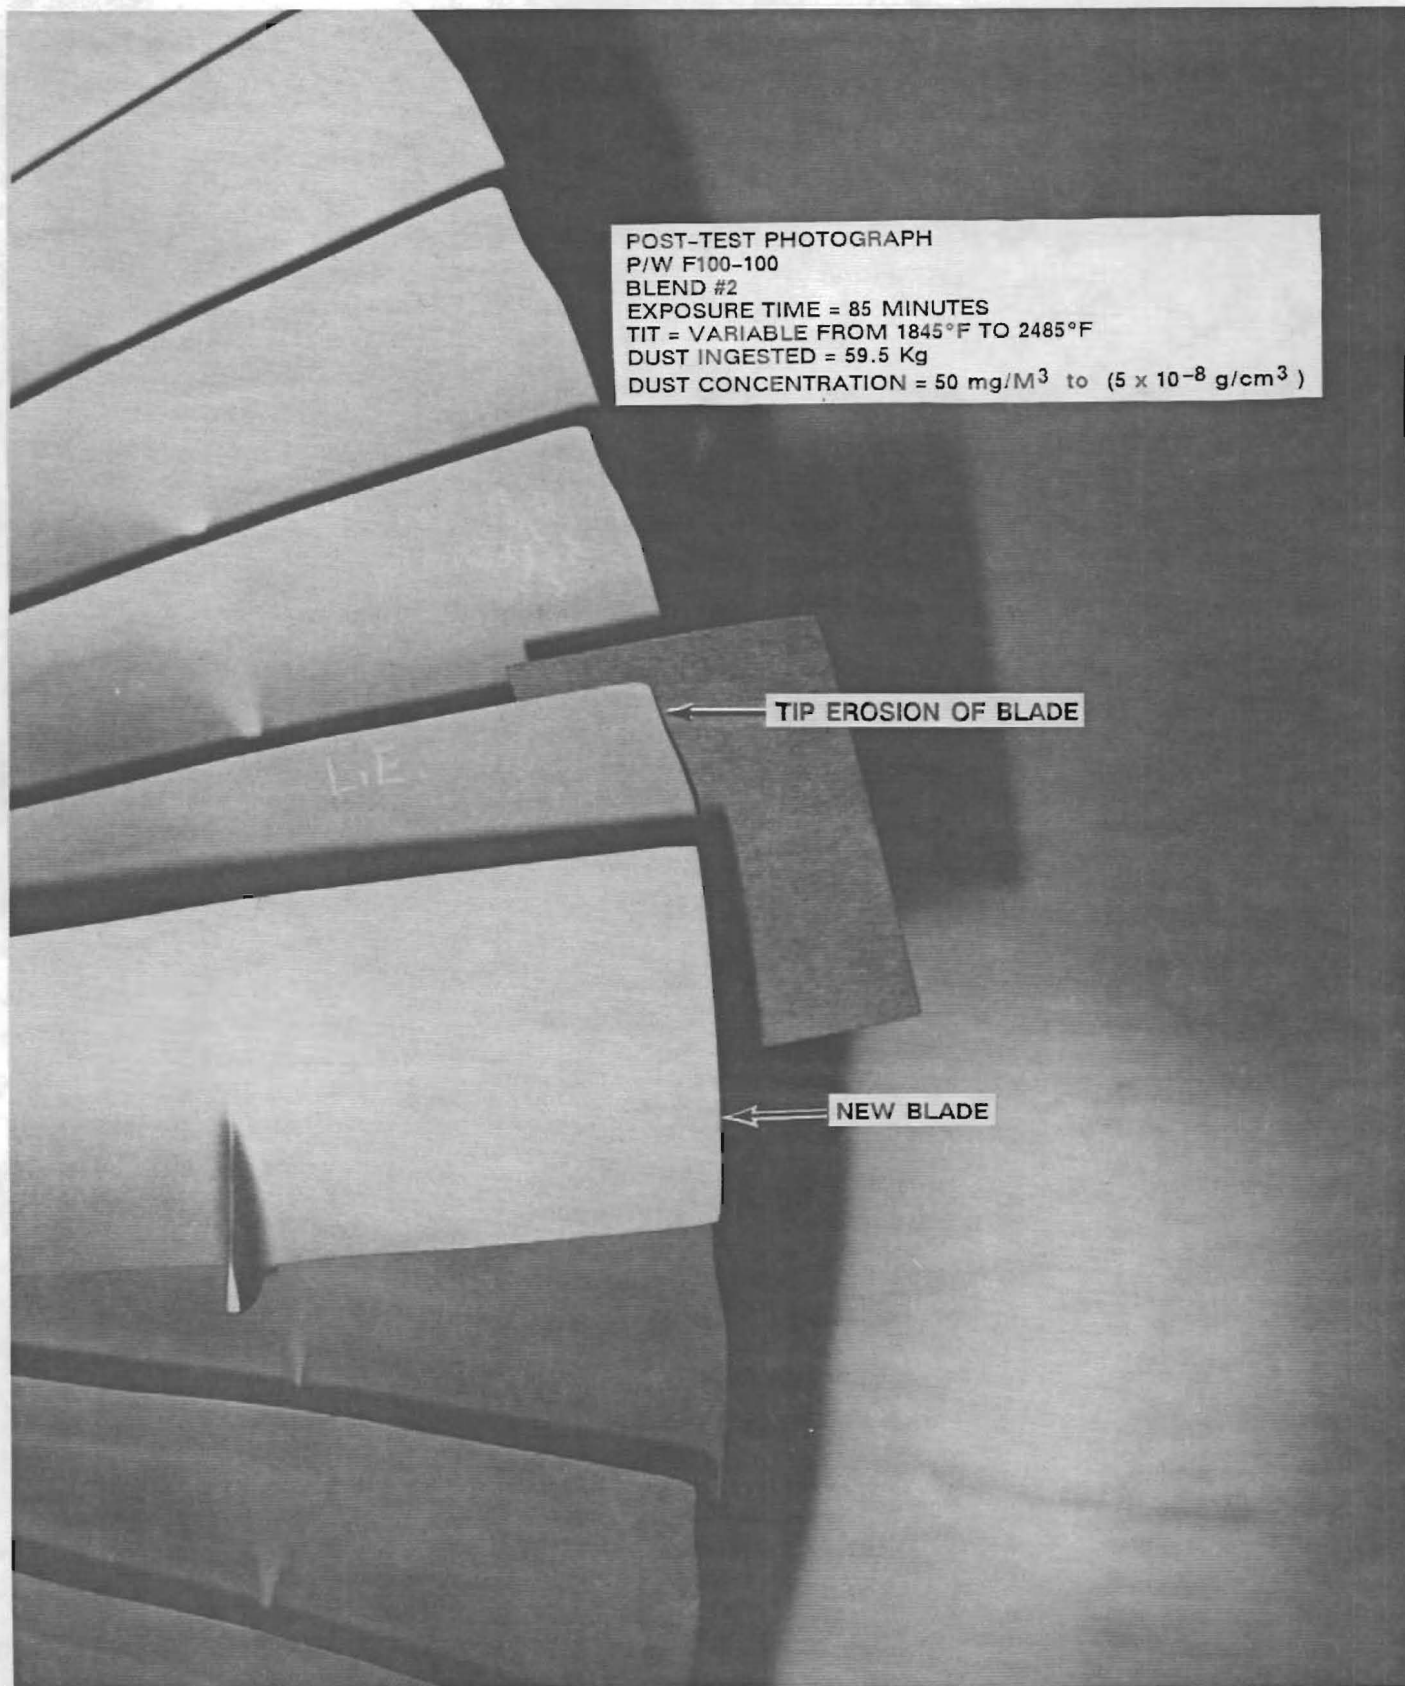
(S) In addition to the difficulties caused in the hot section of the machine as a result of exposure to the dust environment, the fan, and the high pressure compressor may also sustain severe damage when operating in a dust laden environment. Figure 4.12 is a photograph of the tip region of the second stage fan of another F-100 engine that was also subjected to blend #2, but under different operating conditions than the components shown in Figures 4.10 and 4.11. This engine test program is reported in detail in Dunn, 1990(a). A new blade has been inserted into the photograph for comparison purposes. The leading edge of the blade is noted on the airfoil and the tip erosion is evident. Tip region erosion occurred on almost every stage throughout the compressor. Figure 4.13 is an example of the ninth-stage compressor blade row taken from this same machine. The trailing edge of the airfoil in the tip region became so thin that the material folded away from the pressure surface.

Figure 4.12. (U) Rear view photograph of second stage fan rotor of F-100-PW-100 after dust exposure.

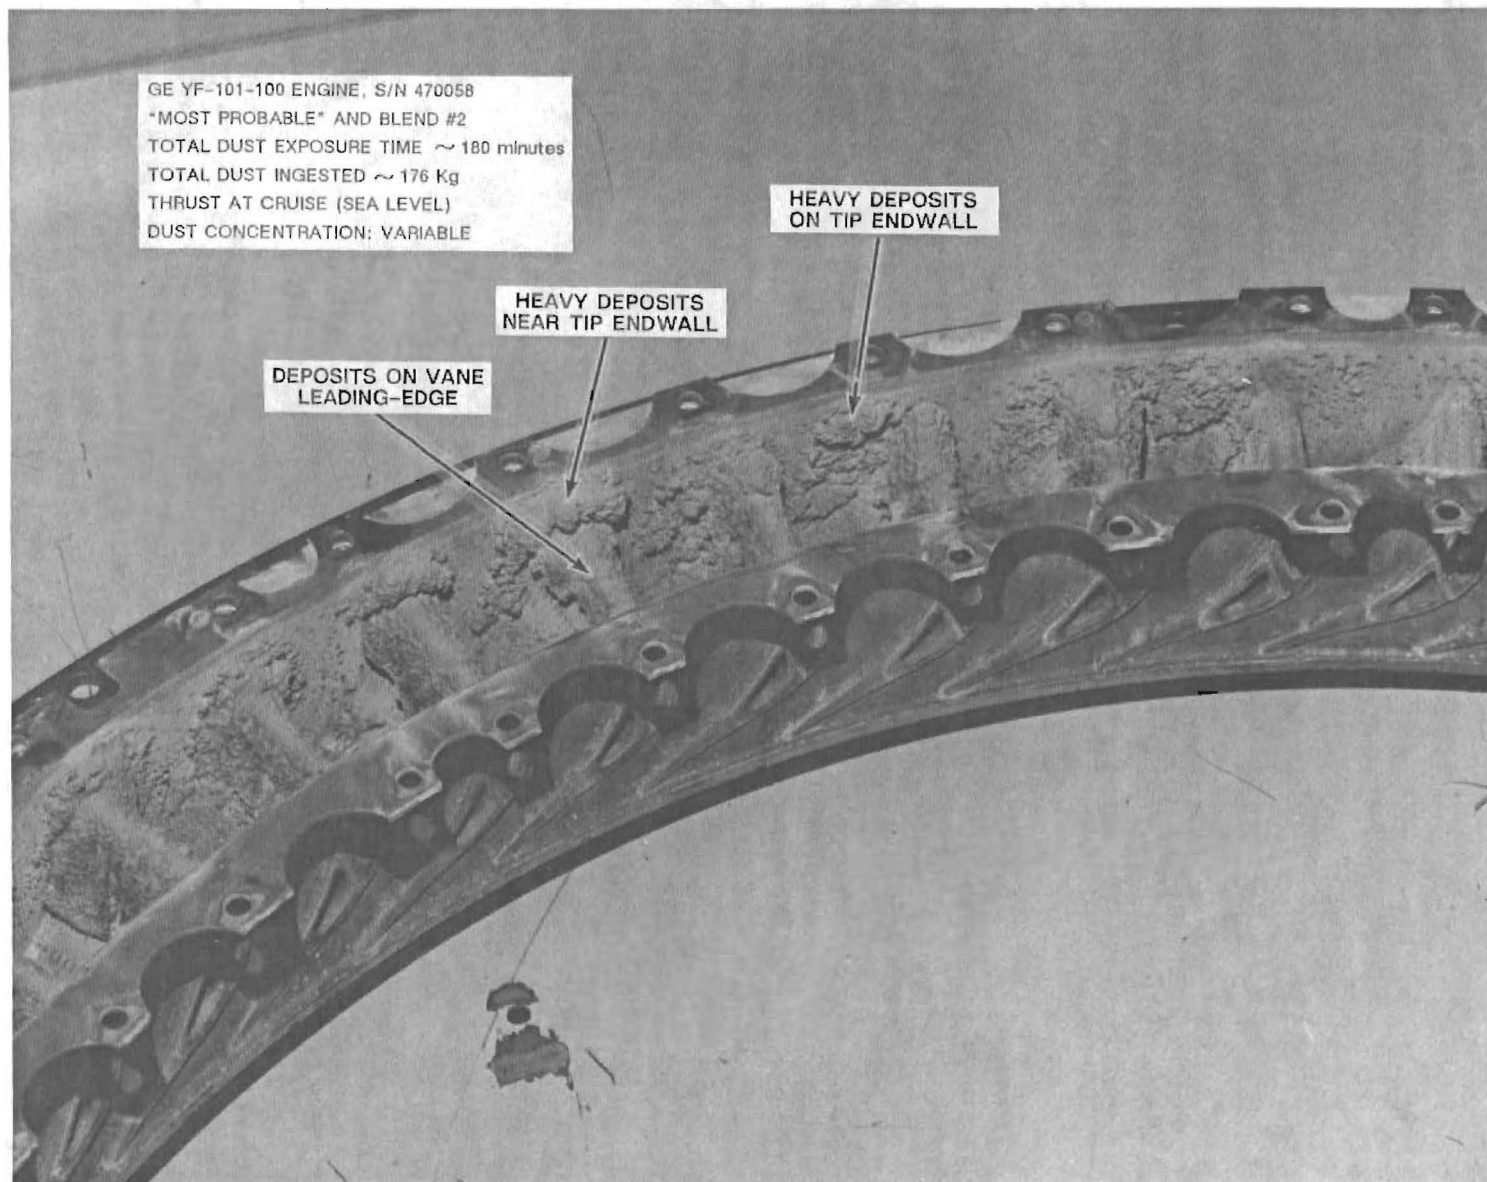
Figure 4.15. (U) Post-test photograph of YF-101-GE-100 hp turbine vane.

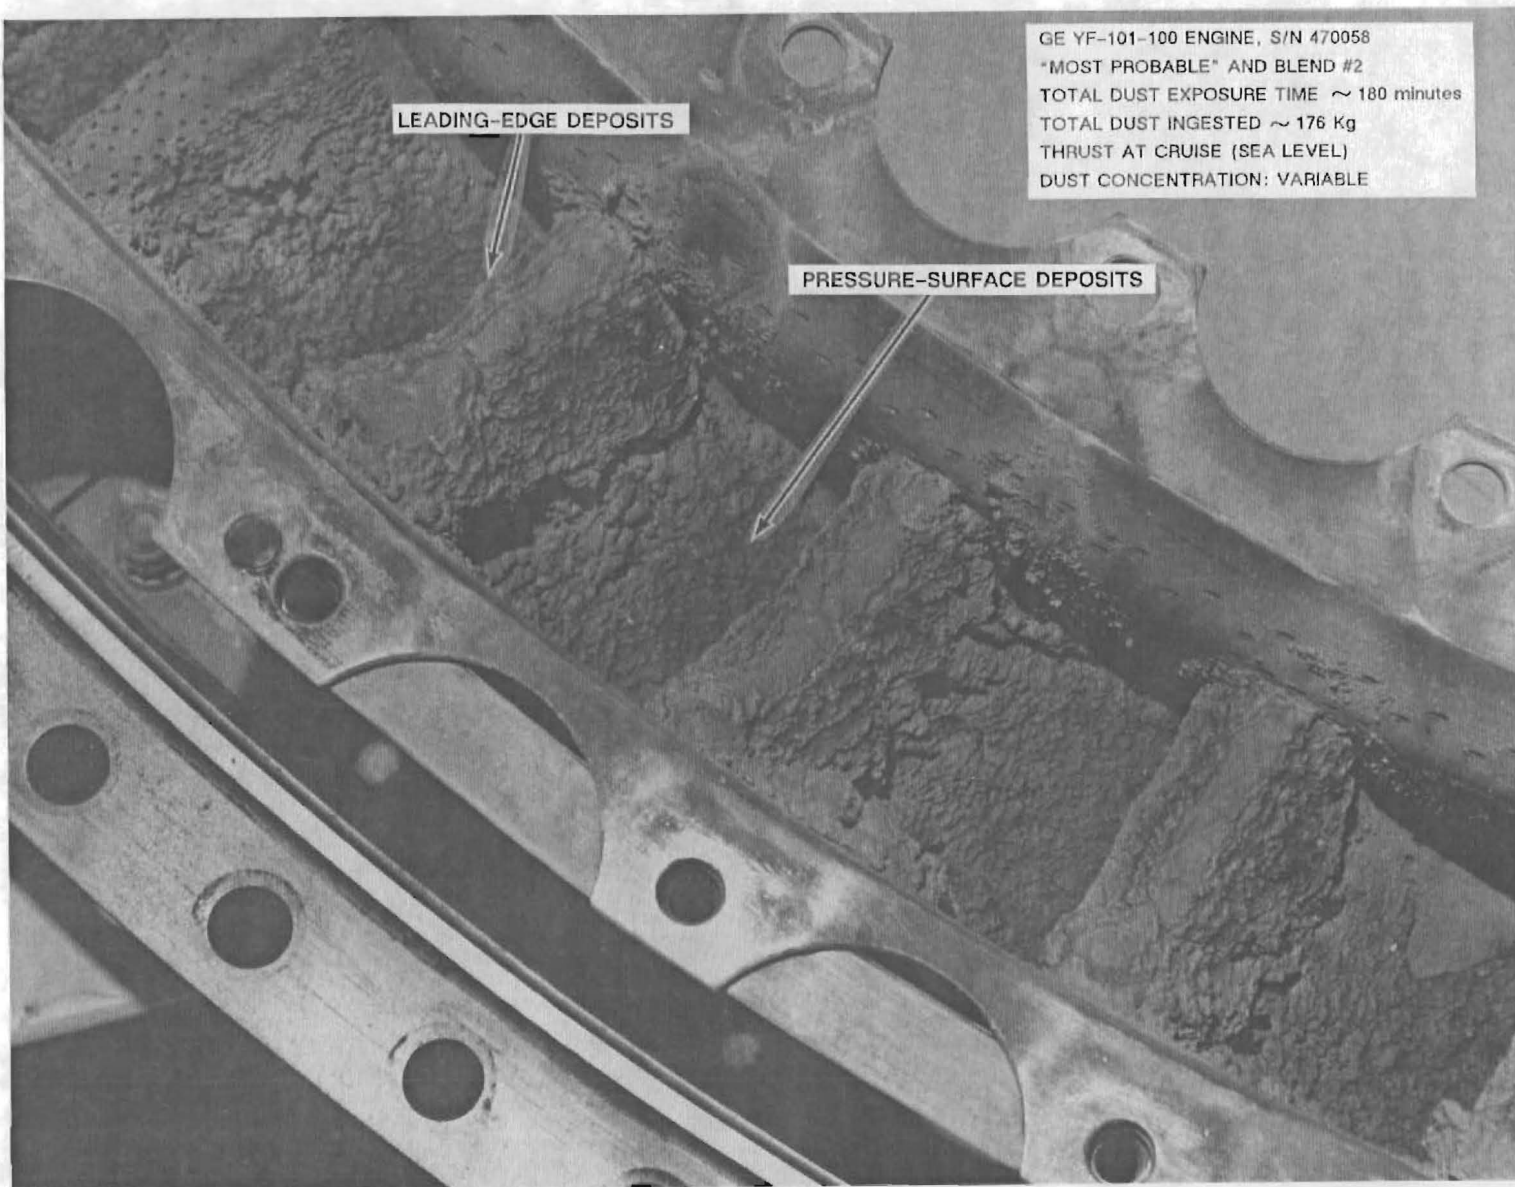
Figure 4.16. (U) Close-up post-test photograph of YF-101-GE-100 hp turbine guide vane.

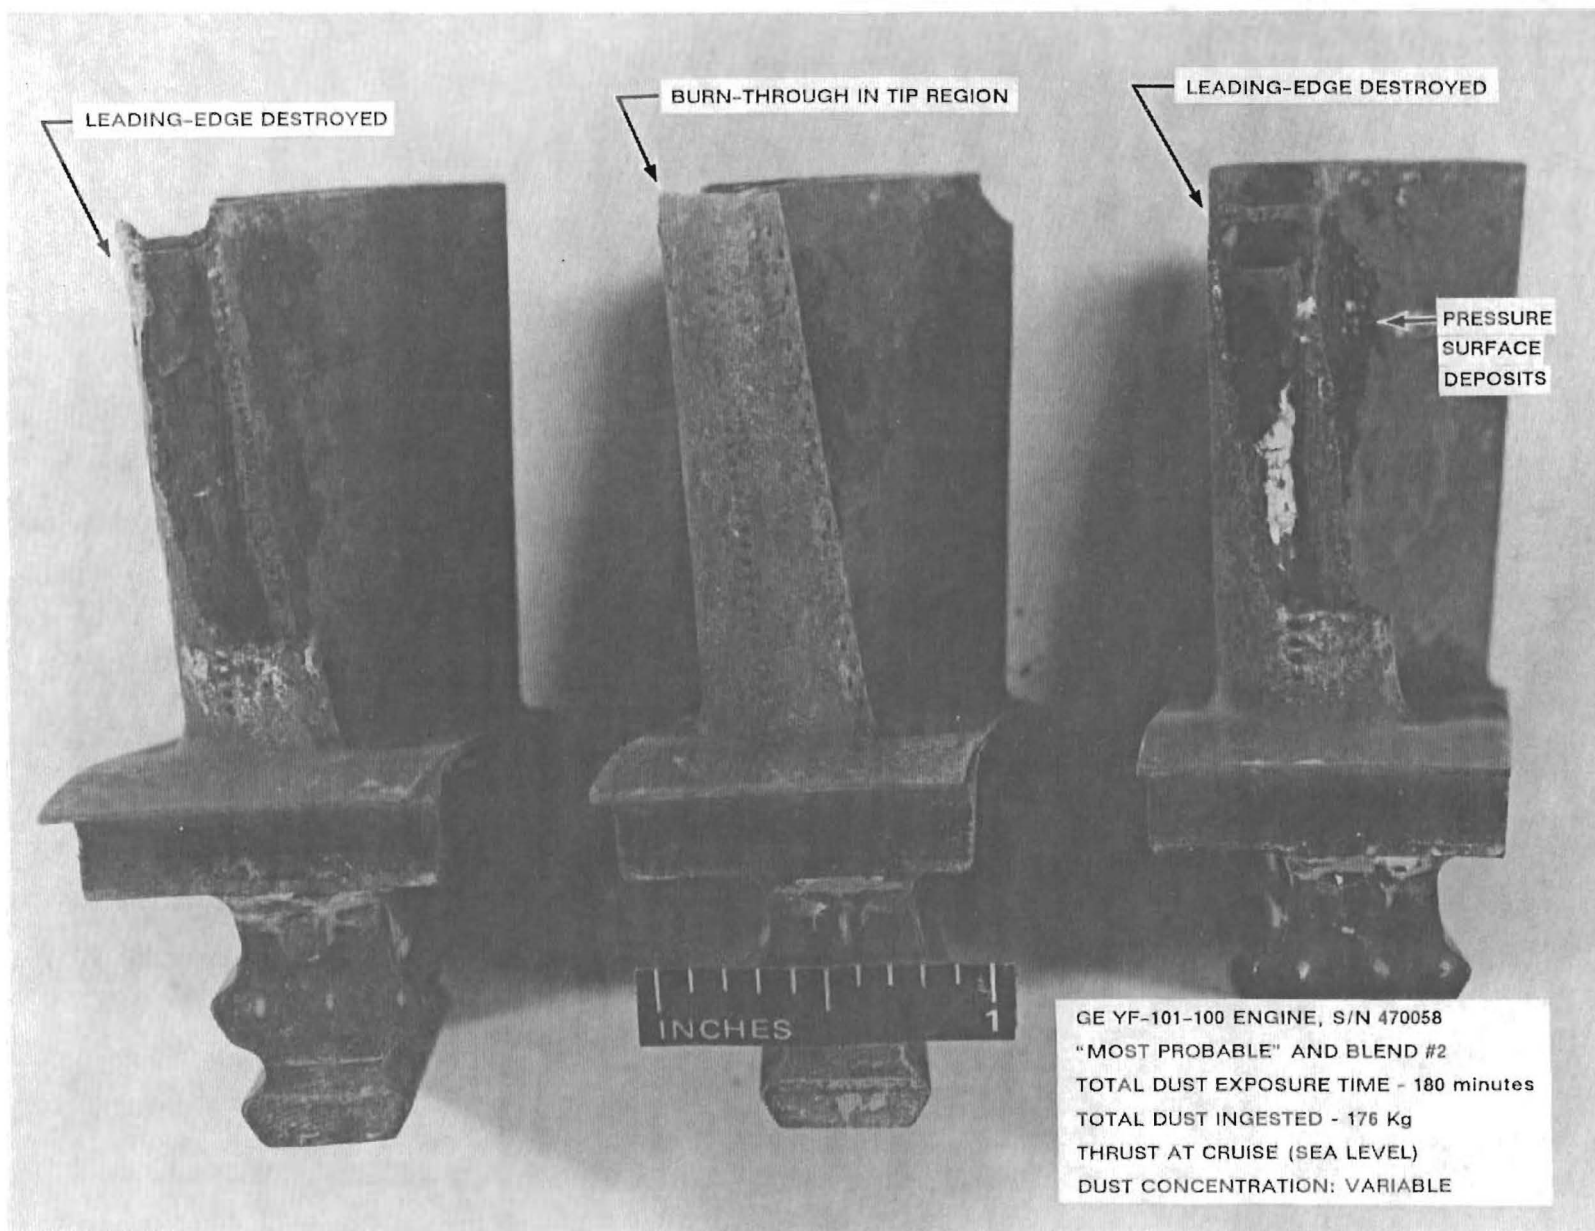
the tip. The portion of the blade from the leading edge to the first row of cooling holes on both the suction and pressure surface has been burned away. This pattern of damage is not an accident. The cooling air for the leading edge comes from an insert tube which can clearly be seen for the blade on the right, and once the holes are blocked the cooling effect is severely decreased. Also note the white deposit on the internal cooling air passage tube. This internal tube has been destroyed for the blade shown on the left of the photograph. Also shown on this photograph is some deposit on the blade pressure surface. The blade in the middle of the photograph has a burn-through in the tip midspan region and at the tip trailing edge. However, the leading edge of the blade has not been destroyed. A close look at the cooling holes indicates that many of them are blocked and that burn-through has begun at about 30 percent span.

Figure 4.19. (U) Post-test photograph of three blades from YF-101-GE-100 high pressure turbine.

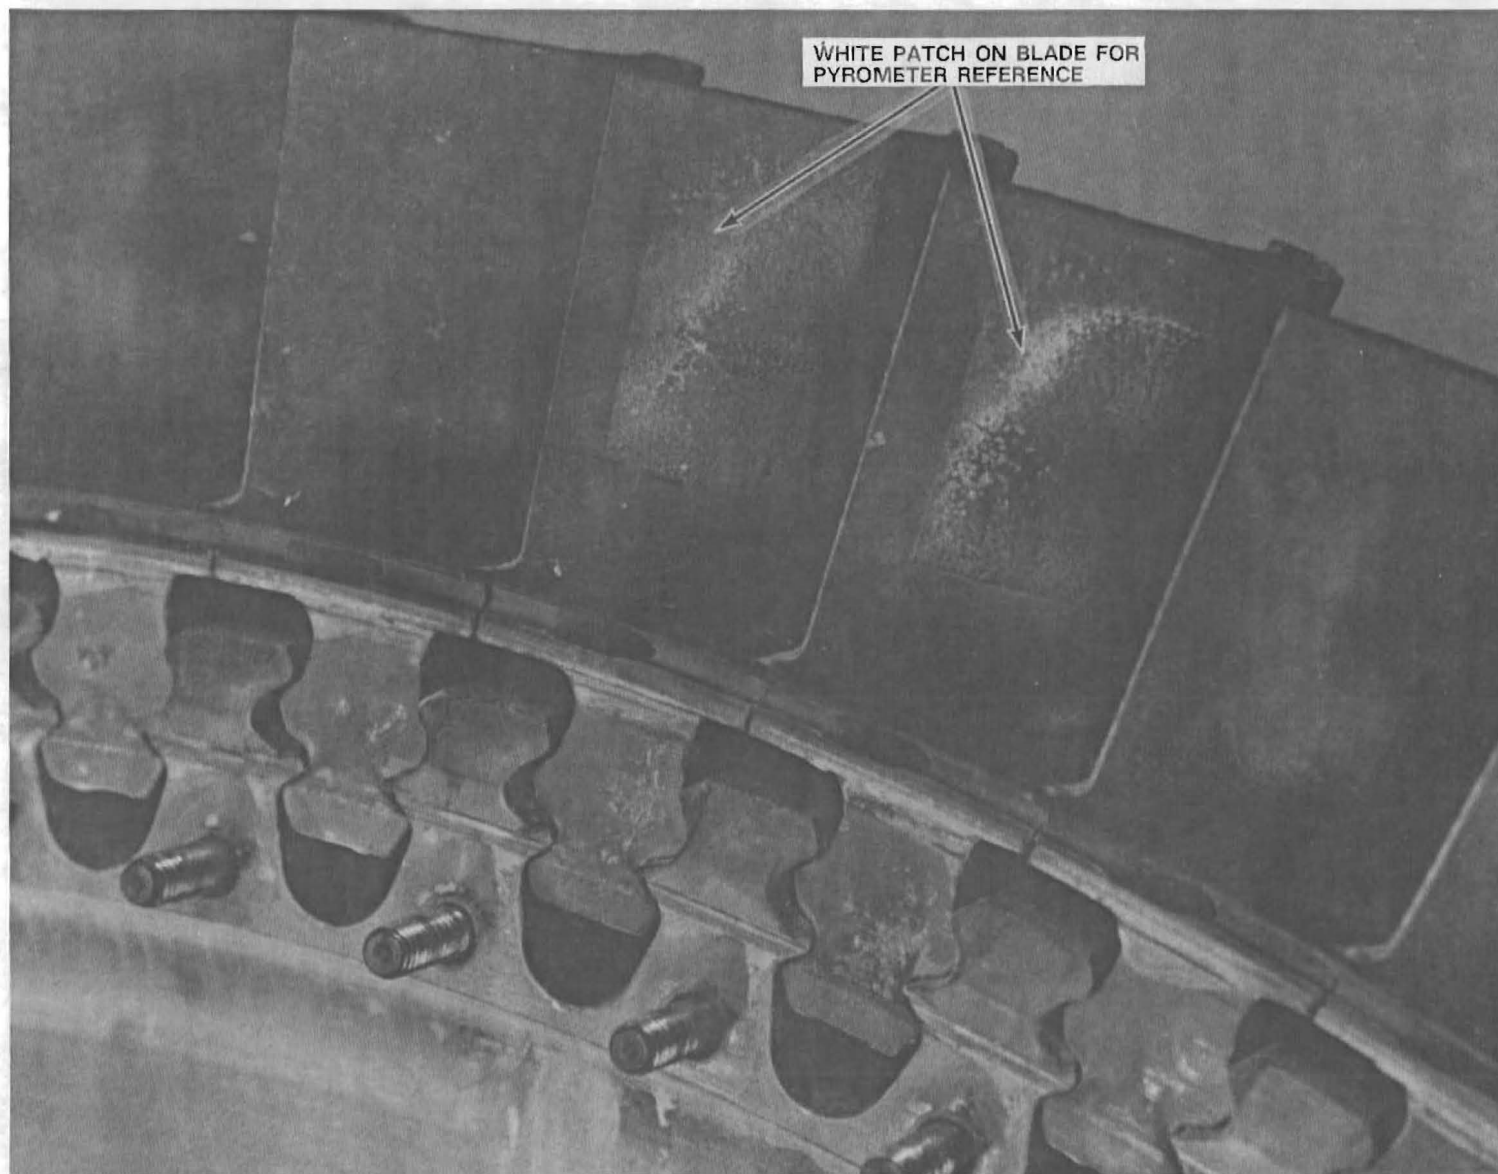
WHITE PATCH ON BLADE FOR
PYROMETER REFERENCE

Figure 4.20. (U) Post-test photograph of YF-101-GE-100 blade suction surface.

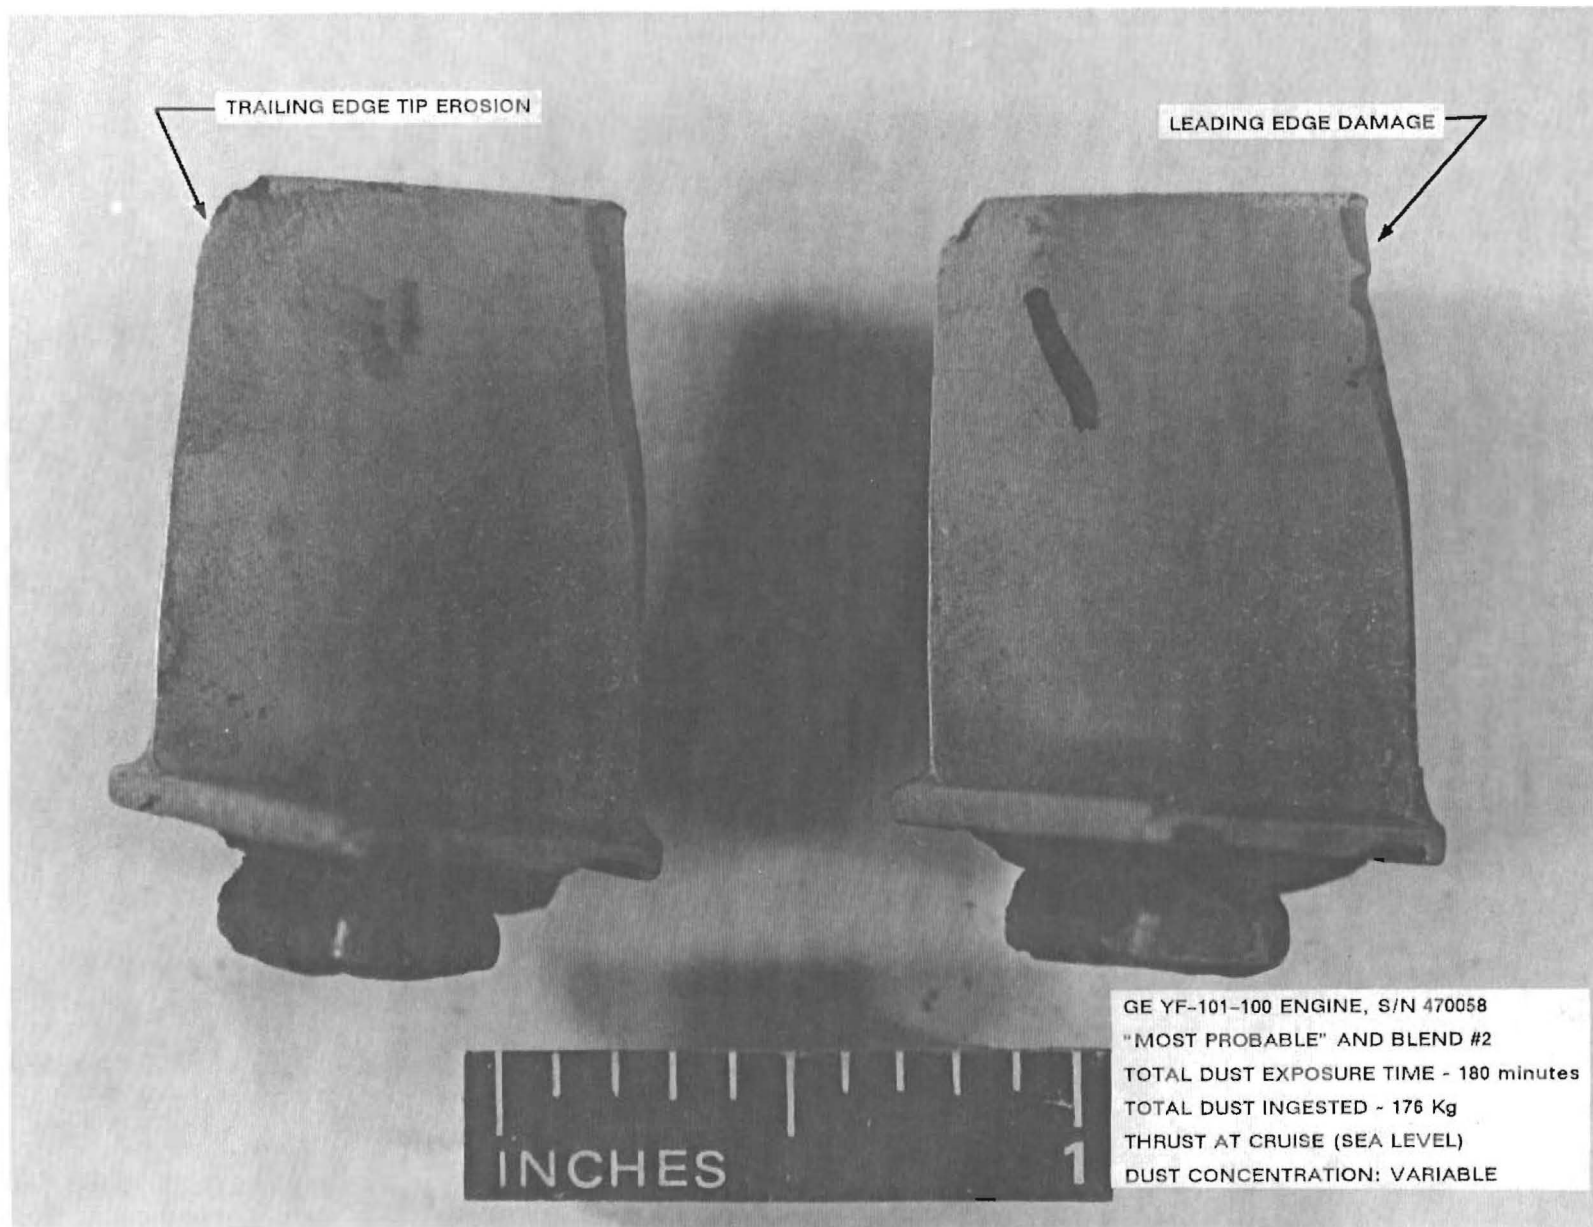
u [REDACTED] The YF-101 engine described in this section suffered extensive deposition on the first vane row and damage to several of the blades of the high pressure turbine stage. At the time the test was terminated, it was not possible for the engine to generate significant thrust. The fan and compressor were highly polished and sustained some damage, but not enough to have rendered the machine inoperable. Figure 4.20 is a photograph of a blade from the 6th stage of the high pressure compressor. This blade has some erosion in the trailing edge tip region, but it does not appear to be severe.

Figure 4.21. (U) Post-test photograph of 6th stage blade of YF-101-GE-100 high pressure compressor.

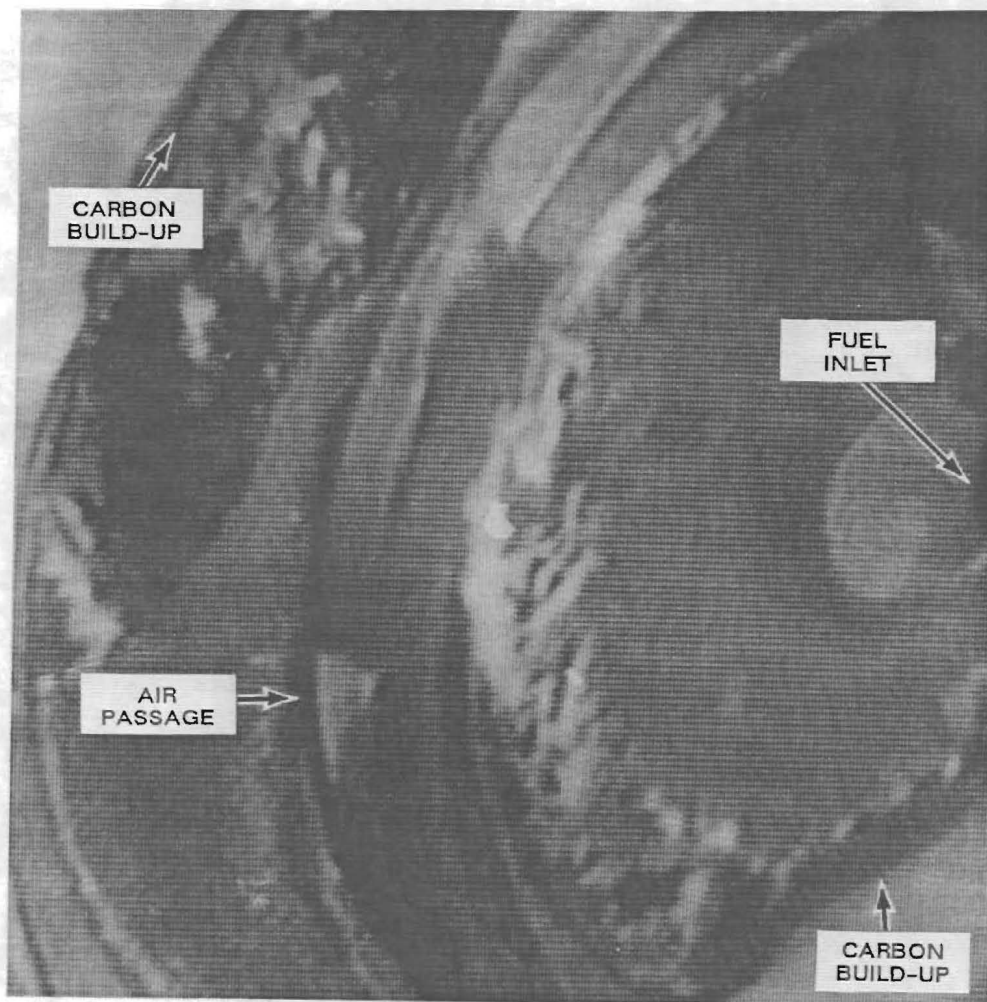
u [REDACTED] The fuel nozzles on this engine are of an entirely different construction from those for the F100-PW-100 engine described earlier and are also very different from the production engine. Figure 4.21 is a post-test photograph of one of these fuel nozzles. There is some carbon build-up as might have been expected, but the unit appeared to be functional at shutdown. Prior to the last test matrix point, difficulty was experienced in starting the engine. However, in order to avoid further damage to the engine by a possible tailpipe fire and subsequent burn down, no attempt was made to restart the engine after encountering the difficulties described in the previous paragraph.

GE YF-101-100 ENGINE, S/N 470058
"MOST PROBABLE" AND BLEND #2
TOTAL DUST EXPOSURE TIME - 180 minutes
TOTAL DUST INGESTED - 176 Kg
THRUST AT CRUISE (SEA LEVEL)
DUST CONCENTRATION: VARIABLE

Figure 4.22. (U) Post-test photograph of fuel nozzles from YF-101-GE-100 combustor.

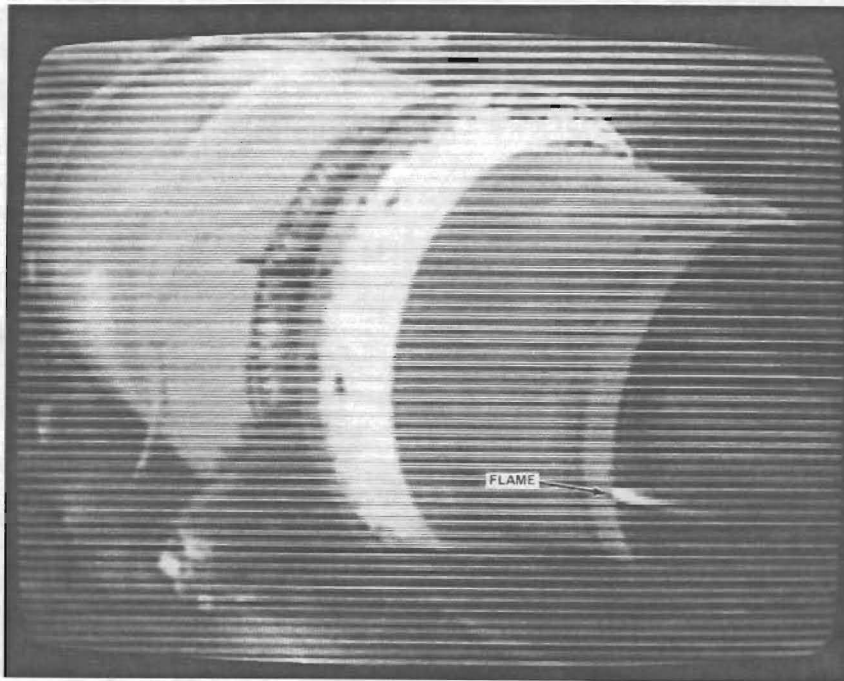
Figure A-16. Photograph of initial tailpipe flame for 2.1 psi overpressure.

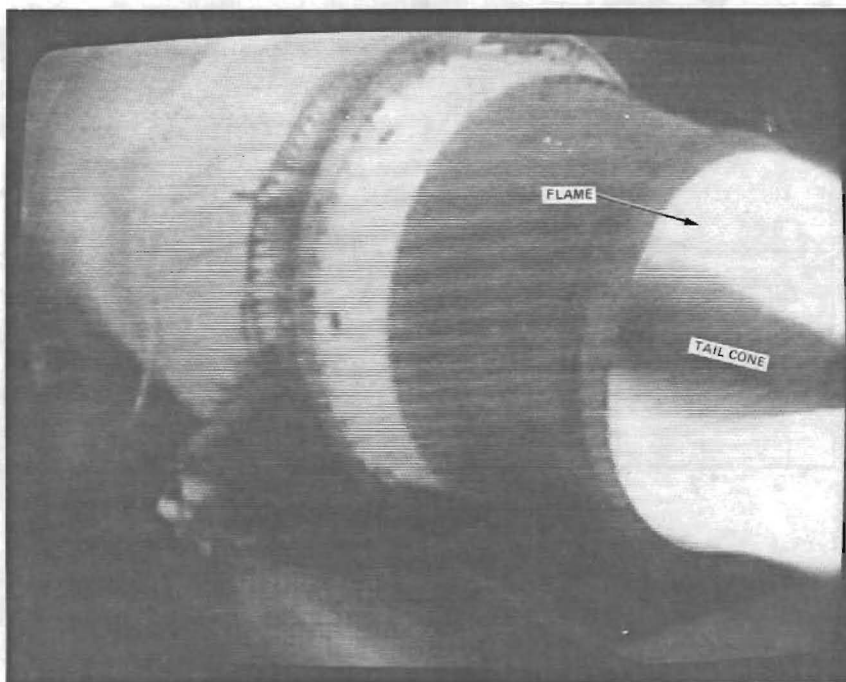
Figure A-17. Photograph of tailpipe surge during acceleration.
